# AME 485 – Aerospace Structures

## Project 2

Henry Glover

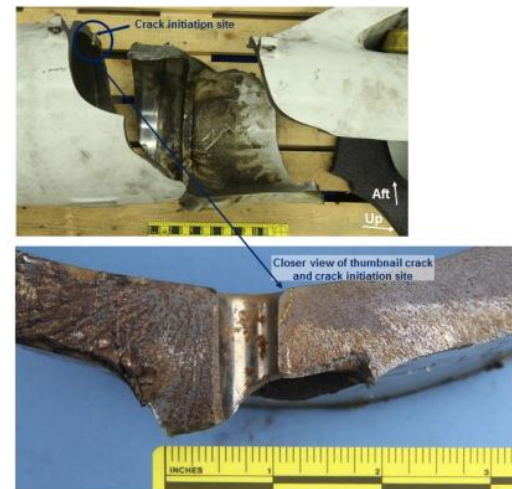
Figure 4 - Image of the air filler valve bore

3. On Friday 28, October 2016 a McDonnell Douglas MD-10-10F converted into a cargo plane owned and operated by FedEx crash landed in Fort Lauderdale International Airport with two occupants inside. Following a successful touchdown on the tarmac, the left main landing gear collapsed after landing on runway 10L. An NTSB investigation found that an overstress fracture emanated from the air filler valve bore. Later findings suggested that the crack initiation was caused by a corrosion pit however, a corrosion repair was completed on the accident cylinder, and it underwent brush cadmium plating per the maintenance manual before being sent back into service. Further investigation found that there was no indications of nickel, chrome, or cadmium plating found at the radius or along the sections of the air filler valve bore where the corrosion emanated from. The lack of any protective coating likely, over time, caused the corrosion pitting.

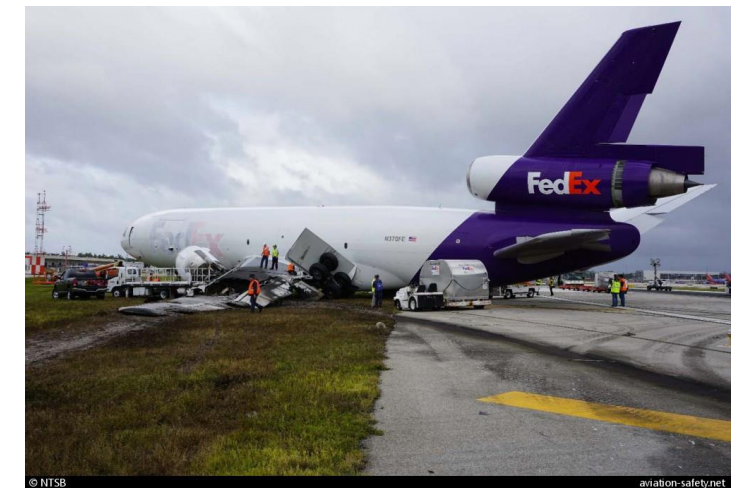
Figure 5 - Image of the accident

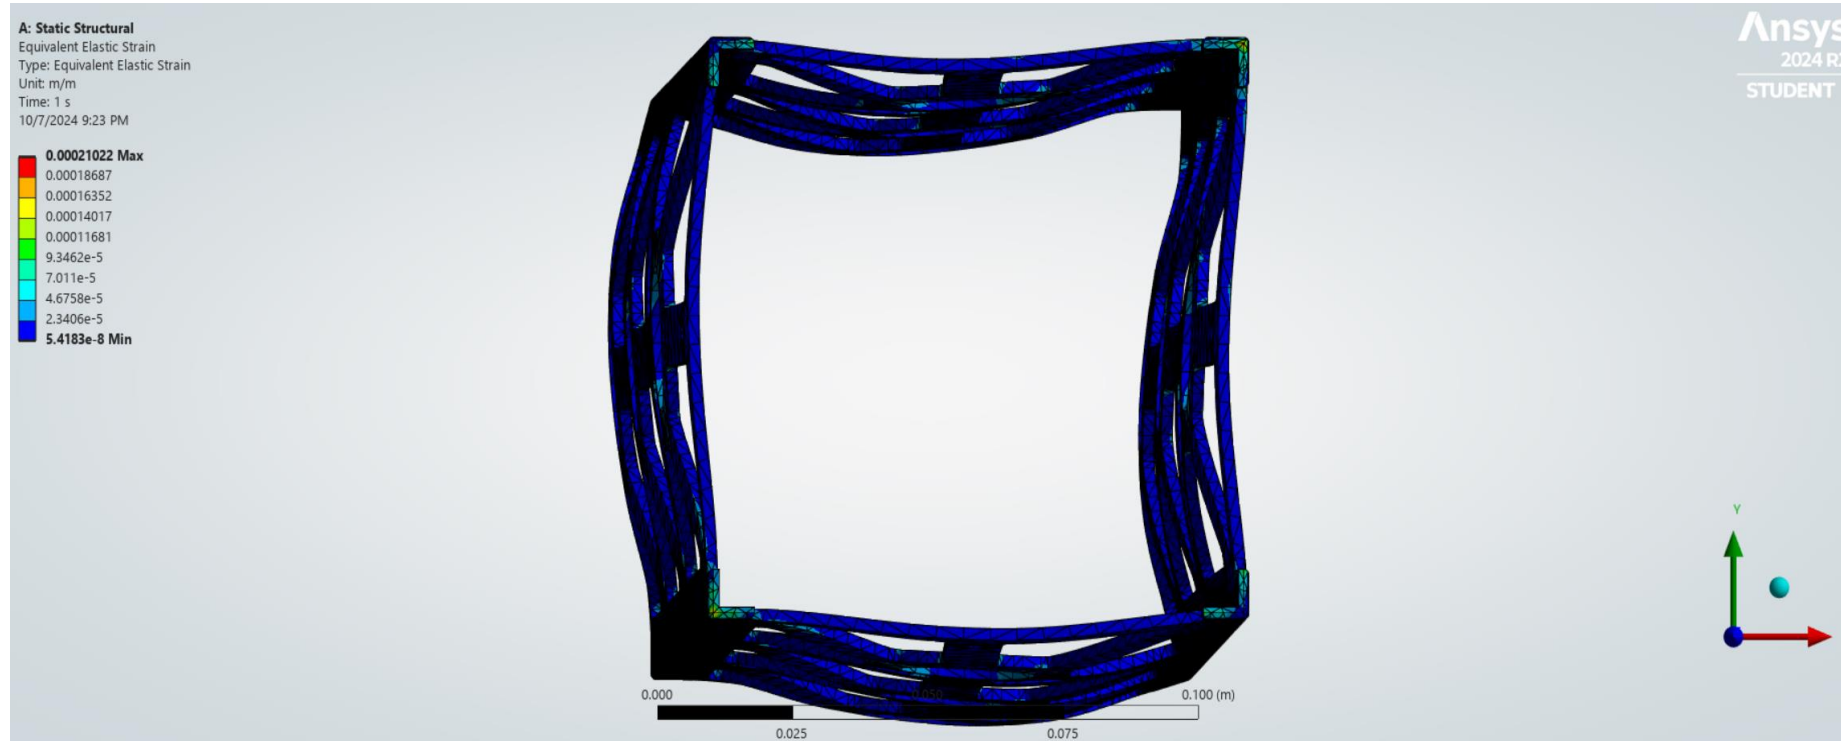
We see from this side view of the elastic strain that most of the strain is located where the fixed support is hence the red/yellow coloring. The side view also give a visualization of the amount of deformation caused by the acceleration load. We hit a max strain of 0.00021022 as indicated in the color chart next to the structure. We hit a minimum strain of  $5.4183 \times 10^{-8}$  m/m.

Figure 8 : Image of the equivalent elastic strain from the z-direction
